**Table of Contents for Bowie Street Tree Permit**  
**Heritage Tree Variance Package**

**PROJECT NAME:** 311,313,315 Bowie Street

**TREE PERMIT:** 10617196

## Tree Assessment Report

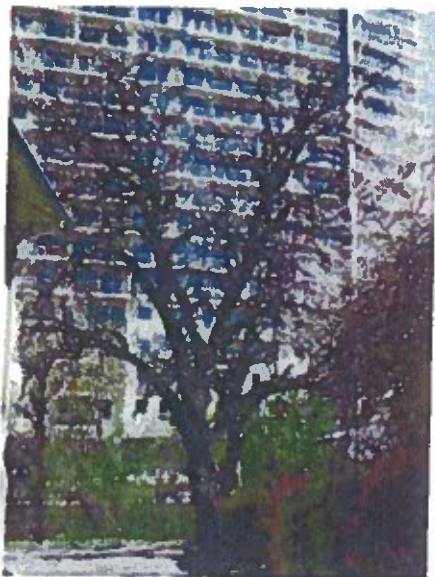
Located at the right rear of the Consort office, this tree stands approximately 60 feet in height. The stem leans 5 degrees toward the north, but the tree architecture is balanced. The crown is medium for stem size and has approximately 5% dead branches with a maximum size of 5 inches. The branch ends are dense and heavy. Two abrupt bends and a sweep are visible in the scaffold branches. A previous failure of a 6-inch limb is visible. The root flare is mostly exposed, and no evidence of root decay was visible upon excavating the south and east sides of the root collar. The root space is limited.

Left photo – structure of Tree #6805.

Tree #6805, however, is a quality tree in good condition. Relocation of this tree is problematic due to the depth of the root ball needed for a successful transplant and the urban nature of the site. Unless an unusually large root zone were left for this tree, development around this large riparian tree would likely cause enough site disturbance and internal soil drainage changes to cause the tree to decline.

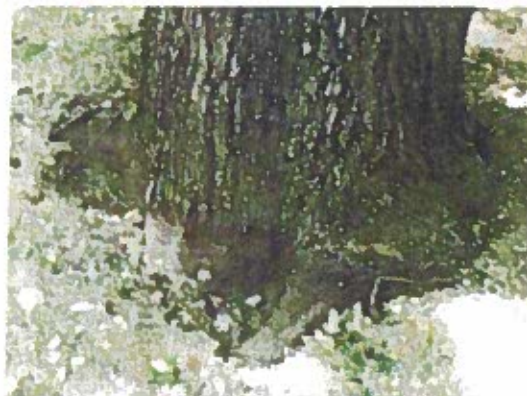
Photo above – root collar of Tree #6805.

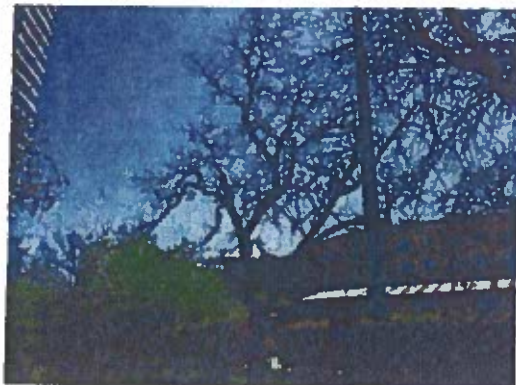
Tree #6806 displays numerous problems. Although the canopy gives the appearance of a healthy tree, the structure of the tree has fundamental problems. The east stem is decayed and cracked and highly likely to fail. Abrupt bends in the scaffold branches, previous failures, persistent dead wood and cavities add to the declining and hazardous condition of this tree. The buried root collar and limited root space have likely contributed to the declining condition of the tree and would likely contribute to further decline of this tree over time.

Left photo – structure of Tree #6806.

With regard to tree # 6806, incumbent decay, root collar disorders, and accumulated stress coupled with high traffic in this area and high pedestrian presence make this tree an unreasonable hazard. Removal of this tree is the recommended before development.

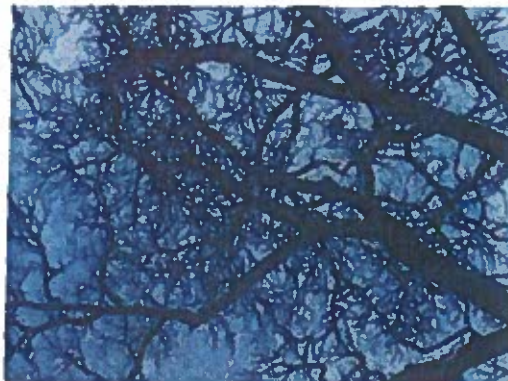
Right photo – abrupt bend in the crown of Tree #6806.

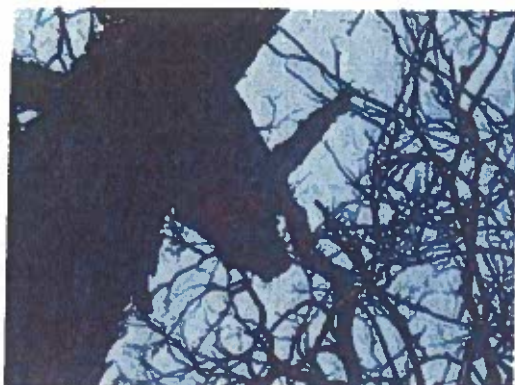
Left photo – decayed east stem and previous storm damage on Tree #6806.

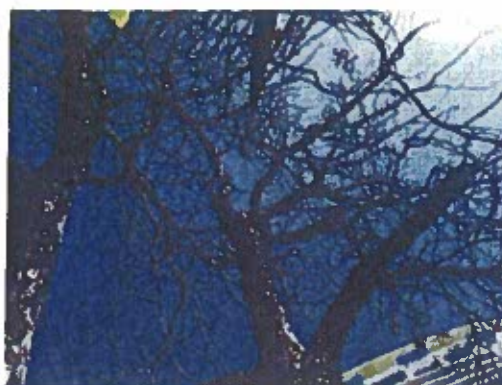
Right photo – broken stubs in Tree #6806 from previous storm damage.

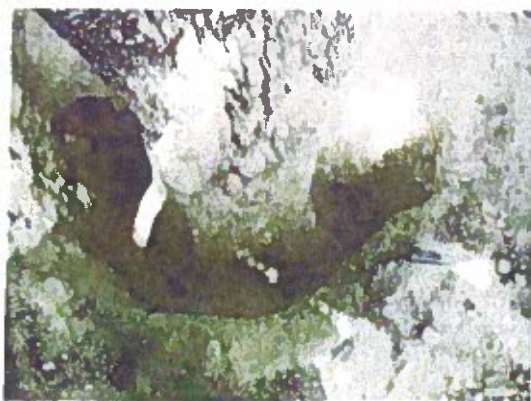
Left photo – view of exposed root collar on the south side of Tree #6806.

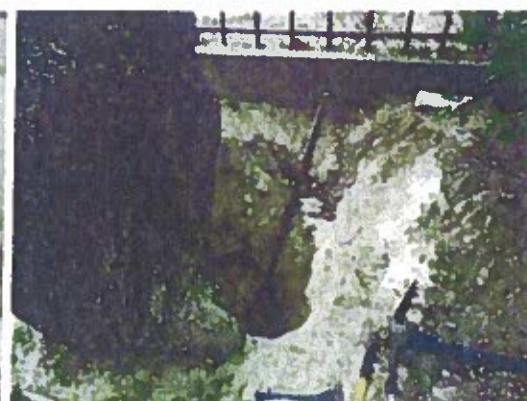
Right photo – view of fill depth (32 inches) over the root collar of Tree #6806.

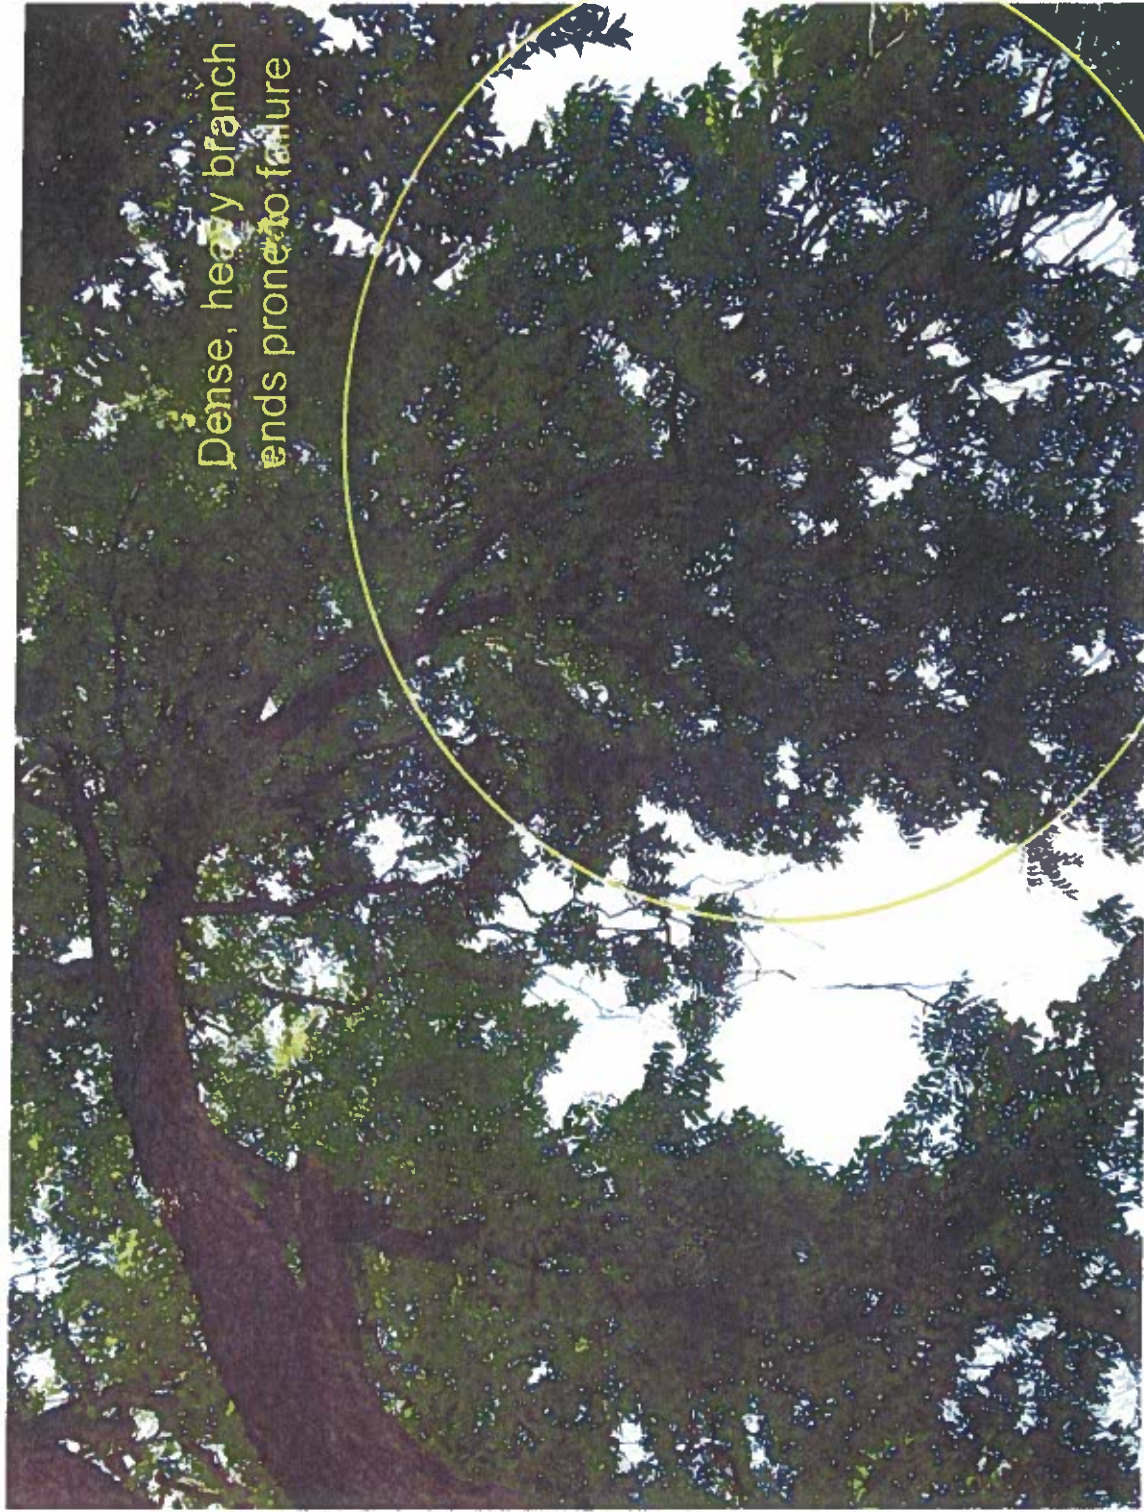
Exhibit 3

Dense, heavy branch  
ends prone to failure

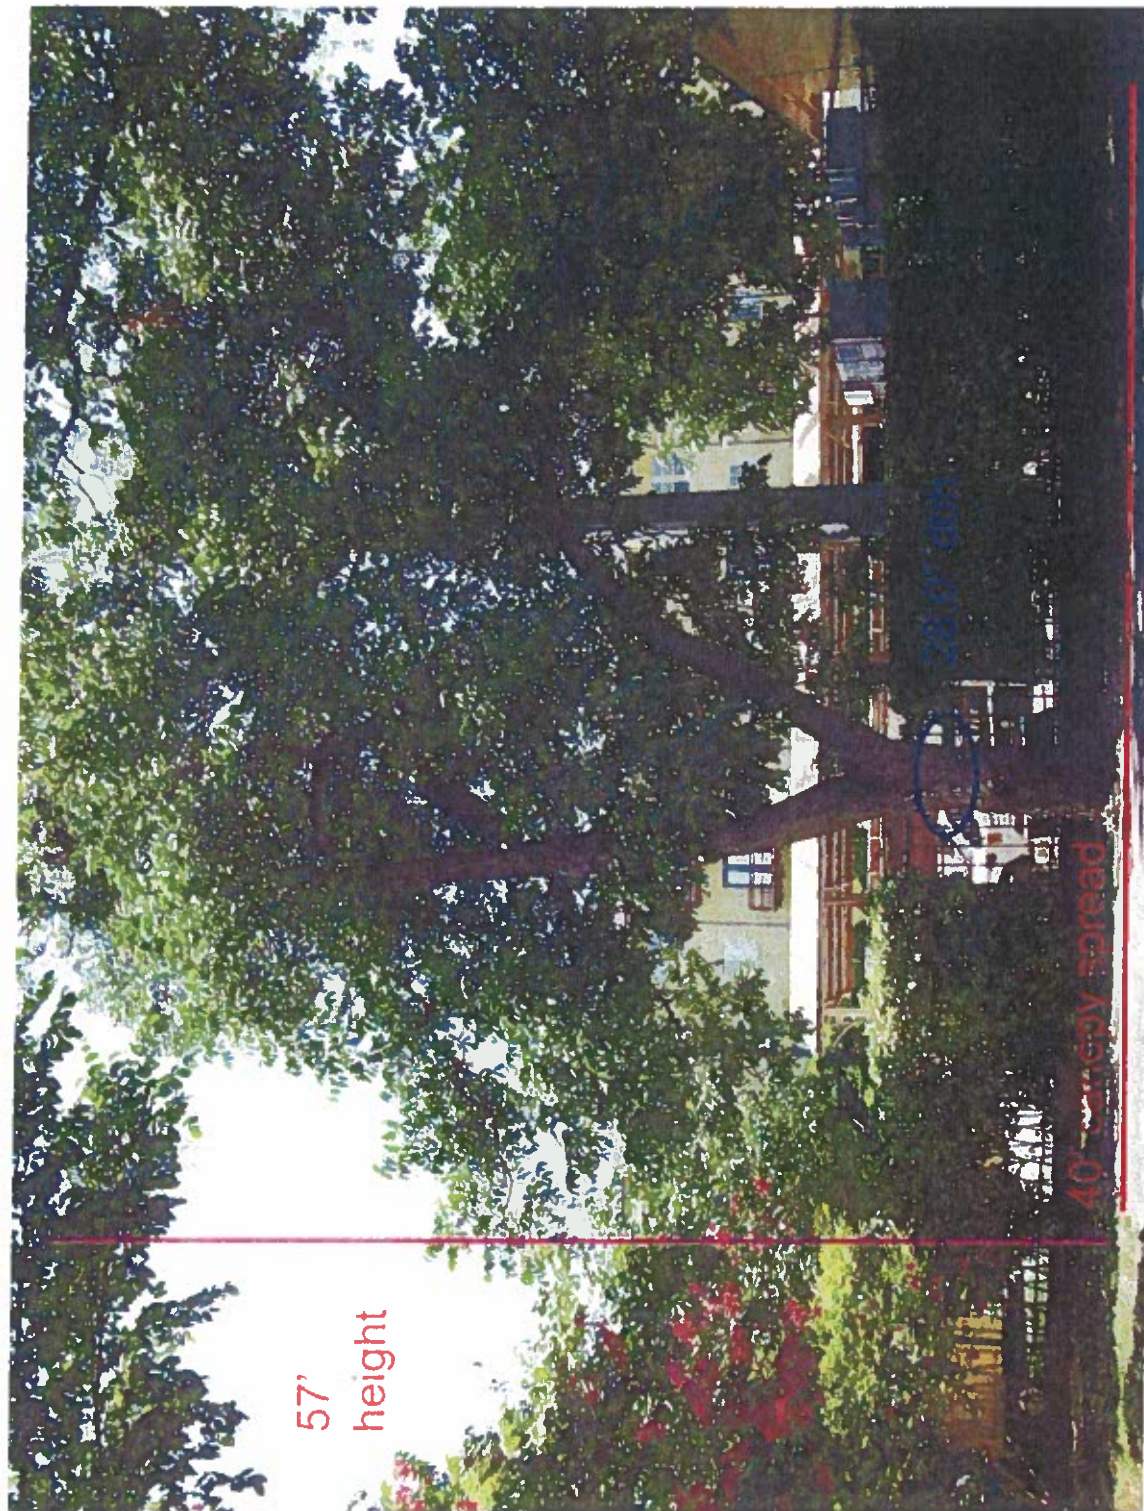
Exhibit 7

There is also a 28.0 inch diameter Pecan onsite that is proposed to be removed (Exhibit 7). This tree displays severe structural defects. There is a 2" x 10" cavity that exhibits

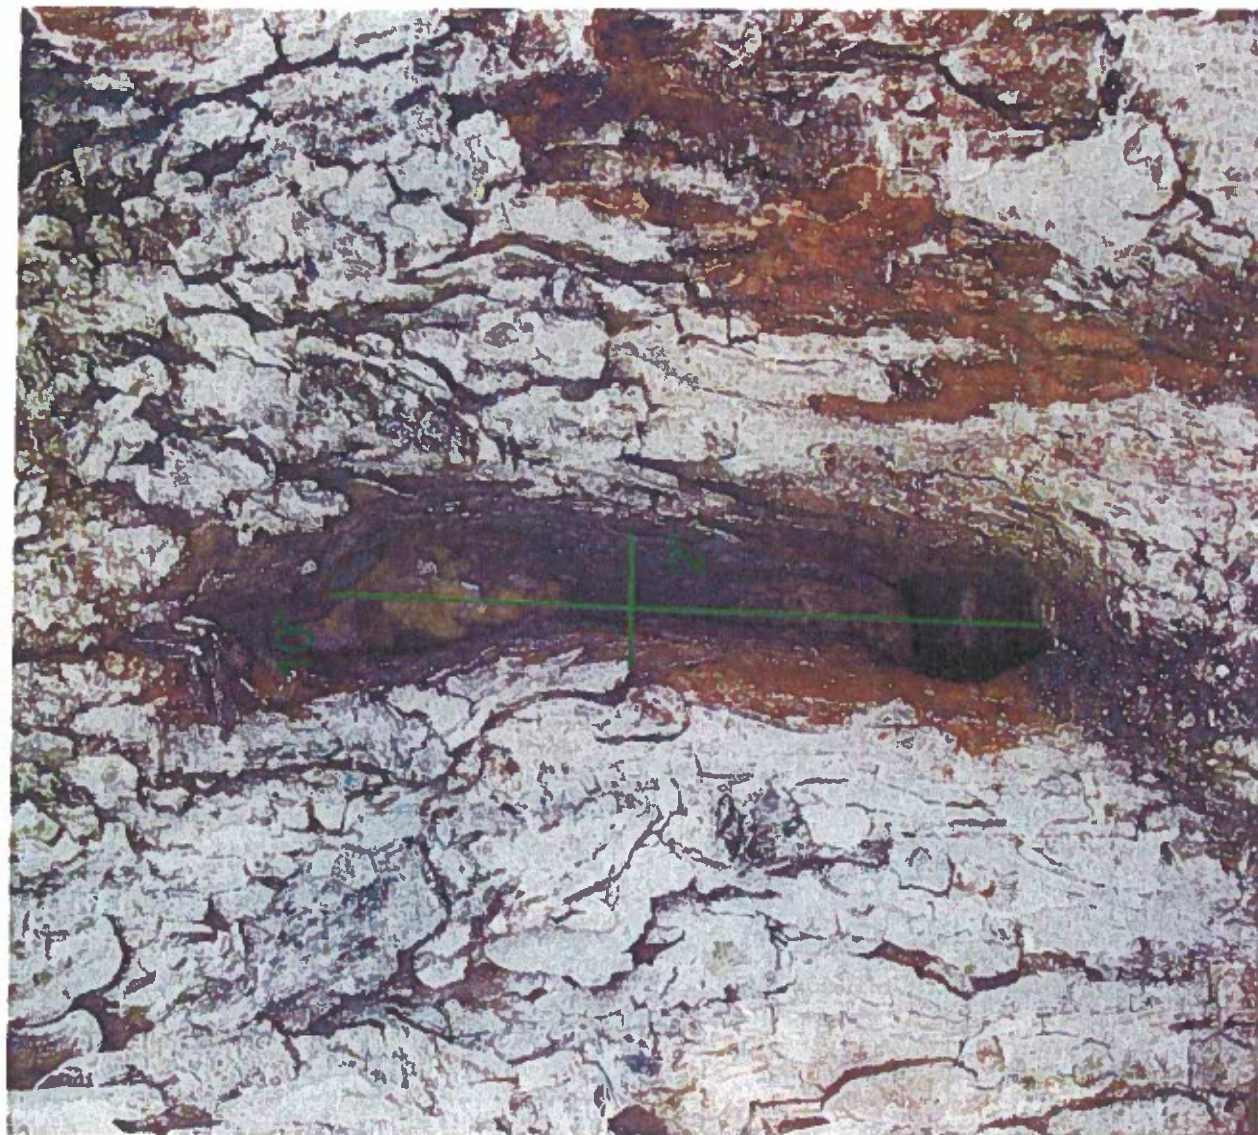
Exhibit 8

significant decay as evidenced by the ~200 in<sup>3</sup> of void space (Exhibit 8). There is also a 8" x 12' decay column in the east stem (Exhibit 9). Further, the root flare has been buried 32 inches with rock, fill, stone, and brick (Exhibit 10) per the Bartlett assessment included in the applicant's memorandum. Given the aforementioned reasons both the City Arborist's assessment (Exhibit 11) and the Bartlett assessment concur that the subject tree is hazardous. The subject tree meets the criteria for administrative criteria for removal per both LDC 25-8-624(5)(a), diseased and restoration is not practicable, and LDC 25-8-624(A)(3) imminent hazard; thus the City Arborist will allow the subject tree to be removed and is not considered part of the variance request before the Environmental Board and Planning Commission.
